AL SUMELAT  
WATER NETWORK  
VILLAGE OF AL SUMELAT, IRAQ

**SIGIR PA-05-004**  
**MARCH 15, 2006**

## **Al Sumelat Water Network Village of Al Sumelat, Iraq Synopsis**

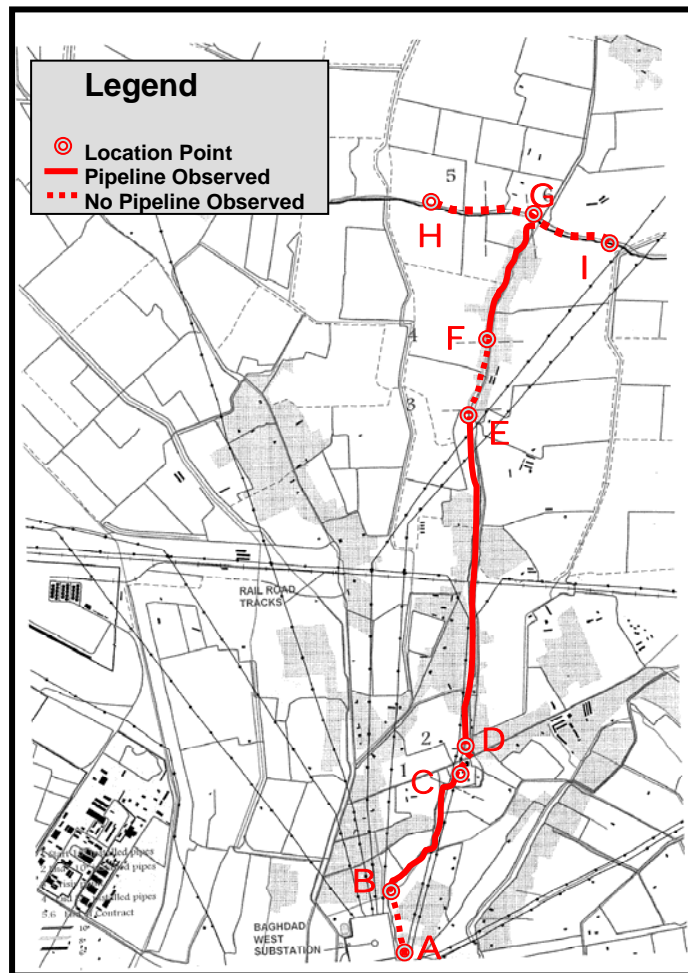
**Figure 1: Al Sumelat Pipeline Location Map**

**Point A to B:** The approximate length of the pipeline from point A to point B (see the locator map in Figure 1 on page 4) is 840 meters. Disturbed soil leading in the direction of the pipeline route was observed from point A. The disturbed soil appeared to be the result of a recent trench excavation and subsequent backfilling of the trench (Site photo 2). It could not be determined how far this excavation continued. The starting point of the pipeline was not visibly protruding from the disturbed soils and could not be located at point A. An observation at point B leading back toward point A along the proposed pipeline path was of an open field showing no recently disturbed soil (Site photo 3). Consequently, no evidence that the pipeline had been installed between points A and B was found.

**Point B:** Point B on the locator map in Figure 1 on page 4 is the point at which the pipeline route crosses underneath an irrigation canal. A recently excavated tunnel approximately 1 meter by 1/2 meter was observed underneath the irrigation canal. The pipeline was not visible leading into (Site photo 4) or exiting the

**Point B to C:** The approximate length of the pipeline from point B to point C (see the locator map in Figure 1 on page 4) is 1,495 meters. Uncapped endpoints of the pipeline were observed at both points B and C (Site photos 5 & 6). The pipe diameter looked to be approximately 225 millimeters, but accurate measurements were not obtained at this location. Disturbed surface soil was observed continuously between points B and C along the proposed pipeline route. The disturbed soil appeared to be the result of a recent trench excavation and subsequent backfilling of the trench. A sand base was not present at the endpoints of the pipeline. A significant amount of unconsolidated soil was observed above grade along the pipeline path. Lack of compacting during backfilling operations would result in the presence of the observed excess soil. The surface of the disturbed soil was uneven with several feet variation in height along the pipeline route. This indicates that final surface grading was not completed. It appeared, based on site assessment observations, that the pipeline had been installed between points B and C, but the pipeline installation was not consistent with contract requirements.

**Point C to D:** The approximate length of the pipeline from point C to point D (see the locator map in Figure 1 on page 4) is 110 meters. The pipeline route crosses a road intersection at this location. A recently excavated tunnel approximately 1 meter by ½ meter was observed beneath the road intersection.

**Point D to E:** The pipeline leg from point D to point E (see the locator map in Figure 1 on page 4) is approximately 3,389 meters in length. This section parallels the road and crosses underneath a set of railroad tracks. The endpoint could not be located at point D and an uncapped endpoint of 225 millimeter diameter pipeline was observed at point E. Disturbed surface soil was observed continuously between points D and E along the proposed pipeline route. The disturbed soil appeared to be the result of a recent trench excavation and subsequent backfilling of the trench. A sand base was not present at the endpoints of the pipeline. A significant amount of unconsolidated soil was observed above grade along the pipeline path. Lack of compacting during backfilling operations would result in the presence of the excess soil. The surface of the disturbed soil was uneven with several feet variation in height along the pipeline route. This demonstrates final surface grading was not completed. It appeared, based on site assessment observations, that the pipeline had been installed between points D and E, but the pipeline installation was not consistent with contract requirements.

**Point E to F:** The pipeline leg from point E to point F (see the locator map in Figure 1 on page 4) is approximately 703 meters in length. This section parallels and crosses under the roadway. A recently dug open trench approximately 1 meter in depth was observed along the proposed pipeline route. Pipe was not visible and the bottom of the trench excavation appeared to be undisturbed soil. At the location where the proposed pipeline route crosses underneath the road a recently excavated tunnel, approximately 1 meter by ½ meter was observed. The pipeline was not visible and could not be located leading into or exiting the tunnel. The bottom of the tunnel excavation appeared to be undisturbed soil. Consequently, no evidence that the pipeline had been installed between points E and F was found. Prior to the site visit, this section of the pipeline was identified as not being completed by the USACE Quality Assurance Representative and is listed in this report under the section on “Work Pending.”
